N.J. NO NAME
DAM NO. 51
NJ 00823

PHASE 1 INSPECTION REPORT
NATIONAL DAM SAFETY PROGRAM

REPT. NO: DAEN/NAP-53842/NJ00823-81/03

MARCH 1981

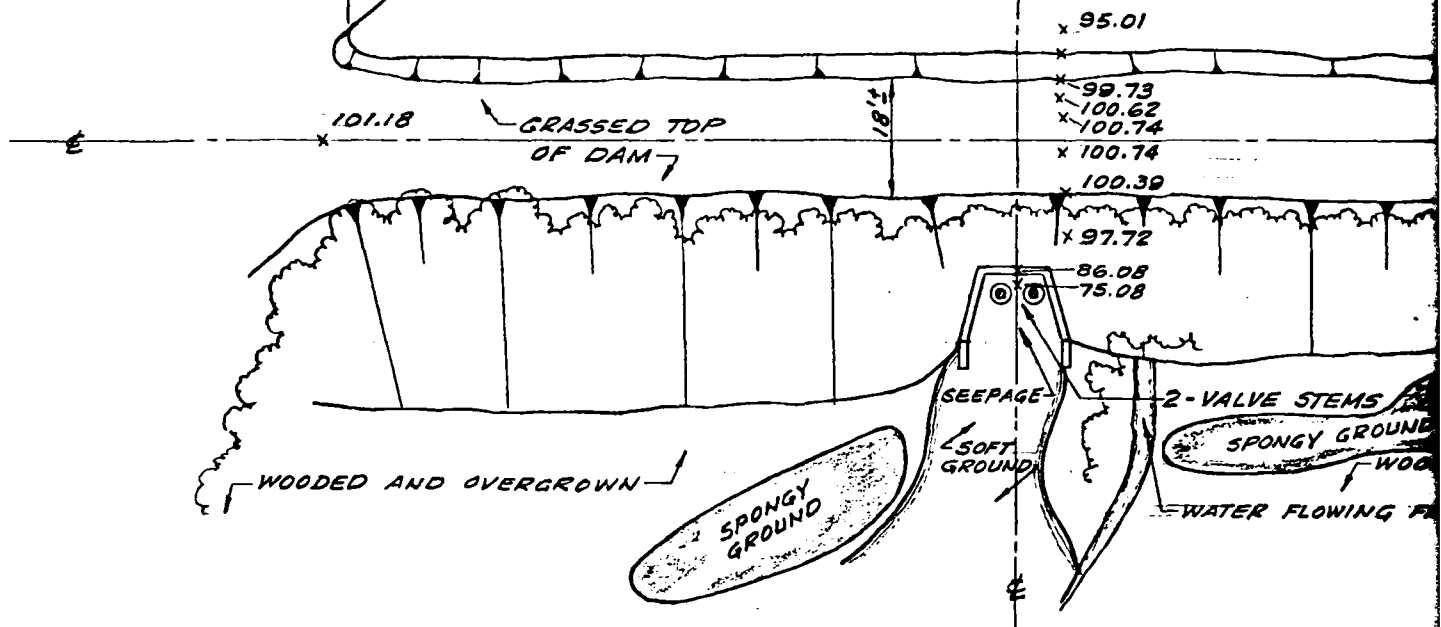
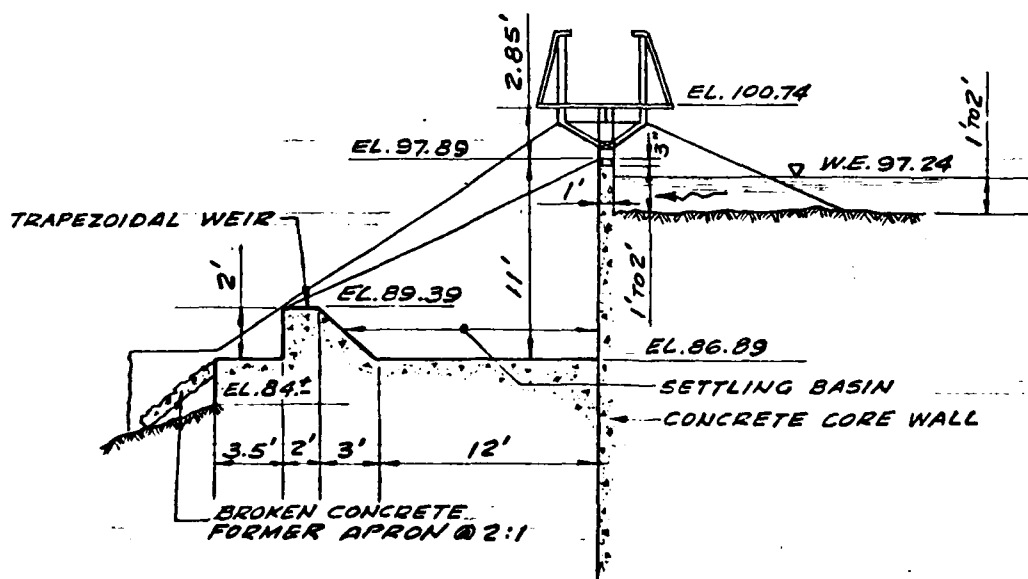
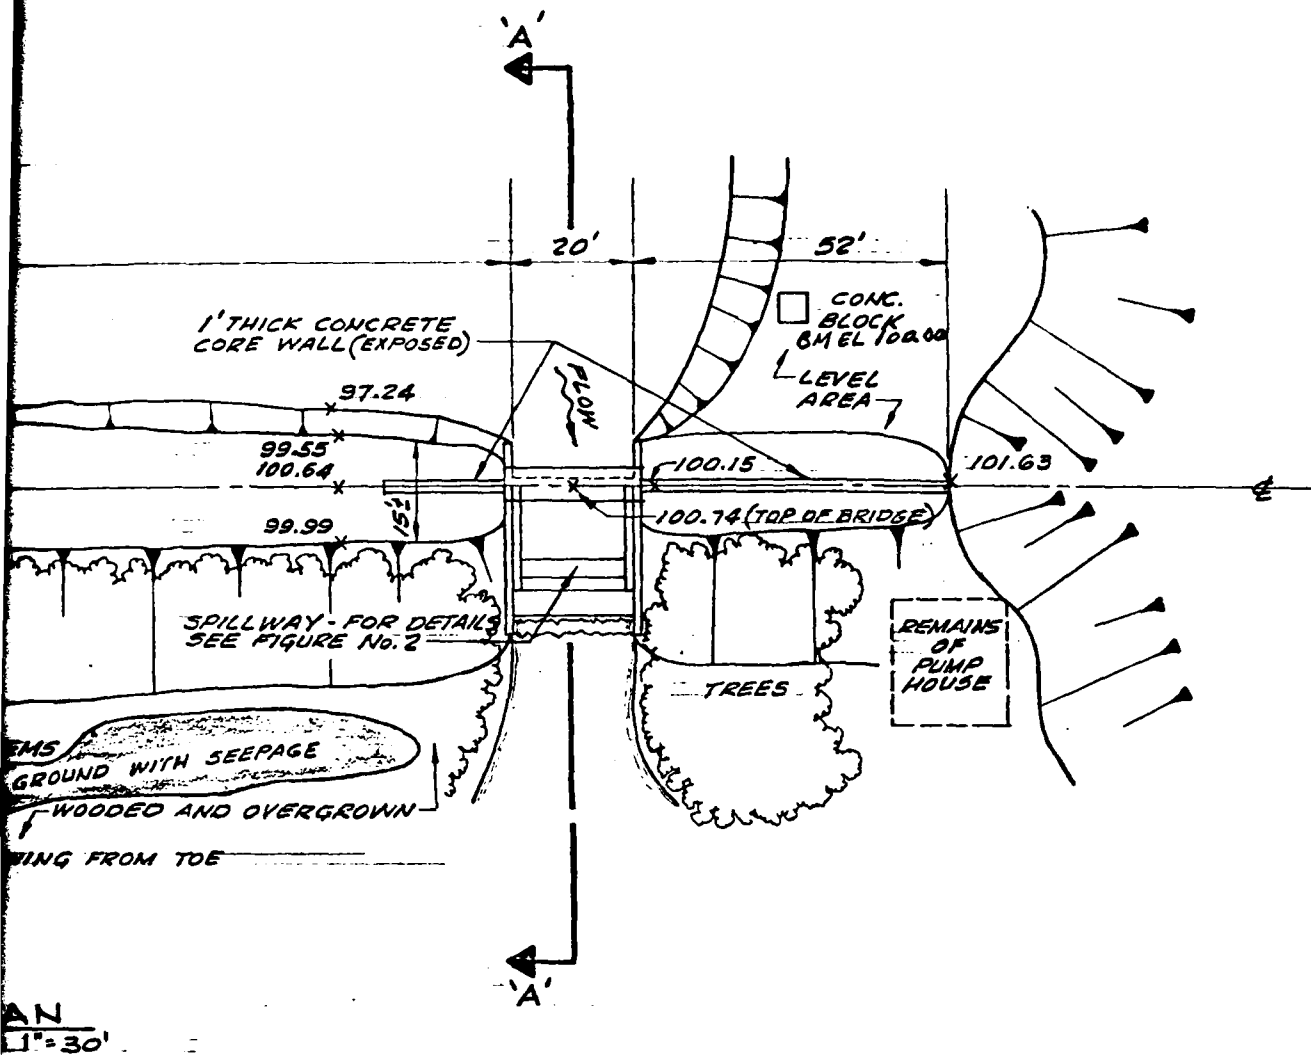
DRN. BY: R.D.	SCALE: AS SHOWN	JOB No. 80145
CK'D. BY: V.U.	DATE: 9-16-80	FIG. No. 2

PLAN AND SECTION THRU DAM NO NAME 51

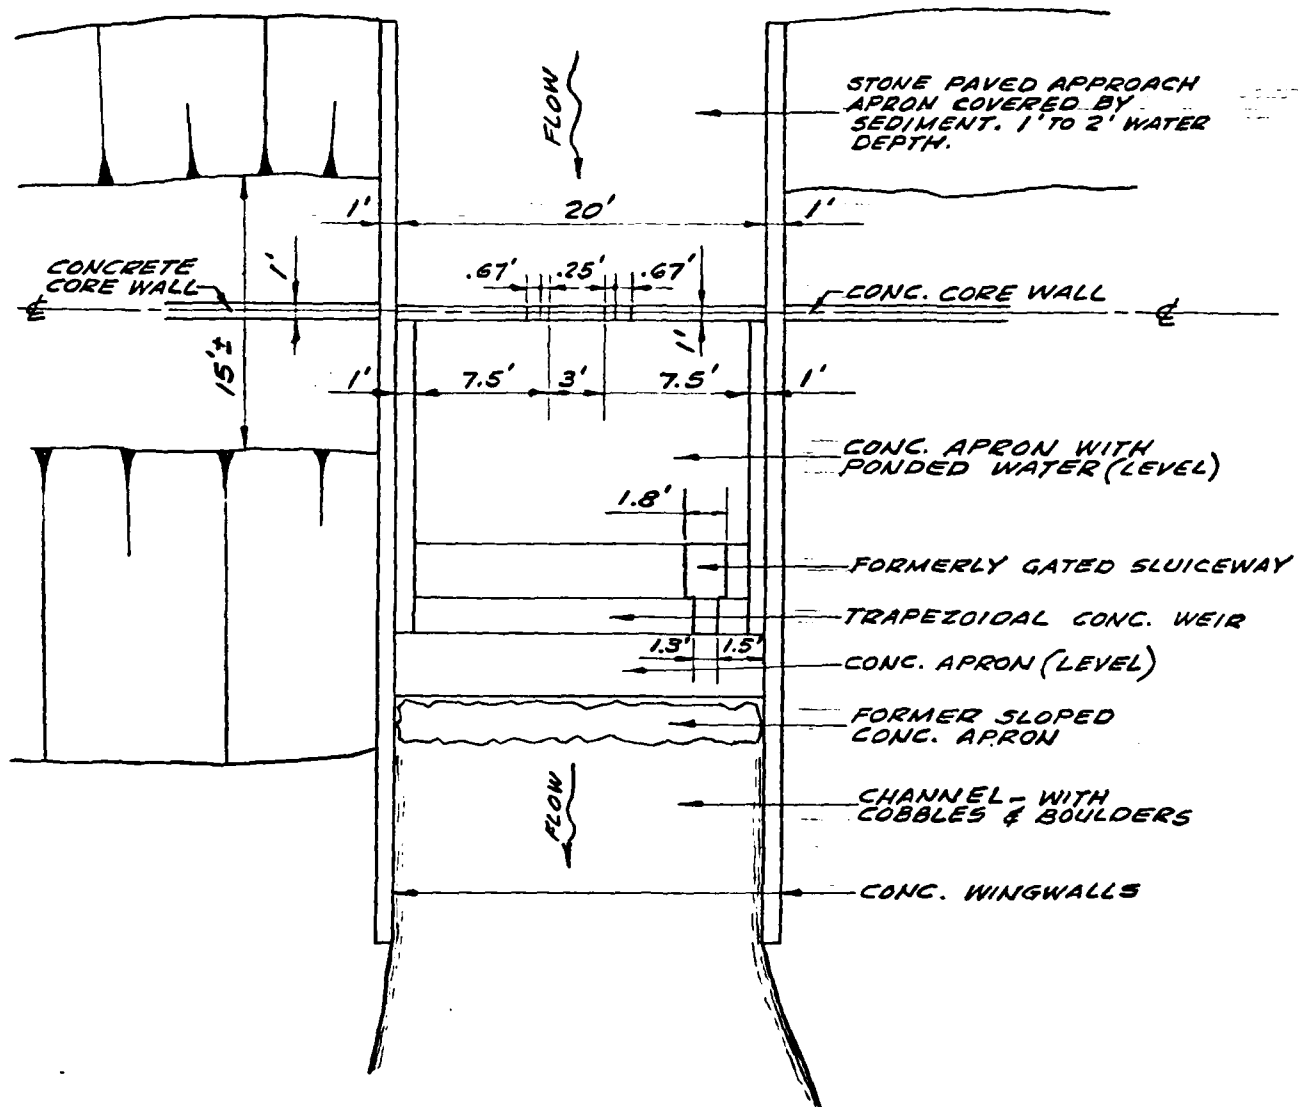
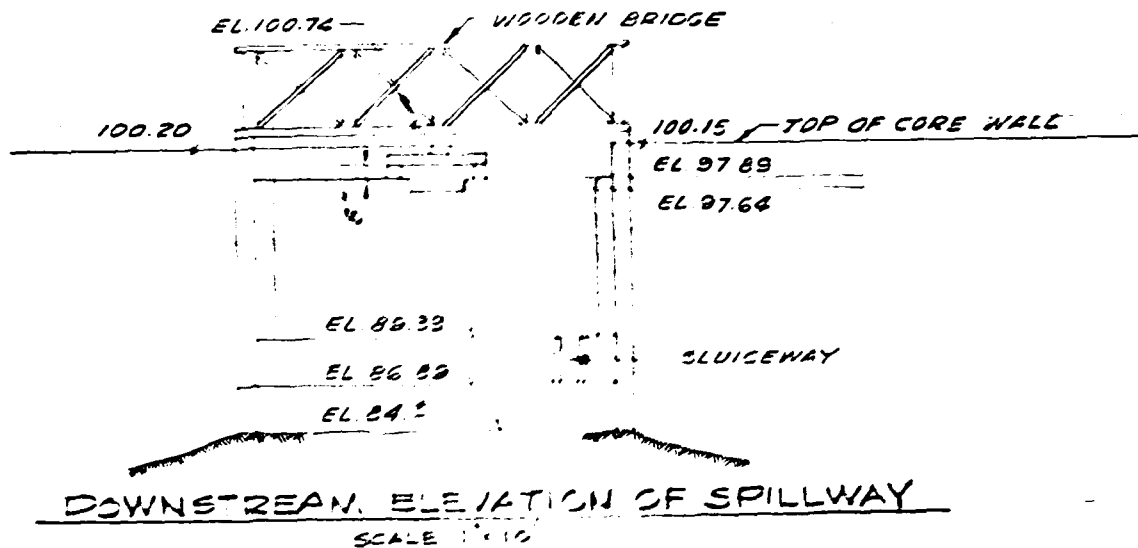
<u>SPILLWAY DETAILS</u>		
<u>PLAN OF OUTLET STRUCTURE</u>		
NO NAME 51 MORRIS COUNTY, N.J.		
LANGAN ENGINEERING ASSOCIATES, INC.		
590 CLIFTON AVENUE CLIFTON, N.J. 07013		
DATE BY	SCALE AS SHOWN	JOB No. 80145
DATE BY	DATE 9-16-80	FIG. No. 3

Approximately 12 ft downstream on the concrete apron exists a trapezoidal broadcrested weir with its crest at elevation 89.39. The weir has a sluiceway cut into it which appears to have been controlled by a 2' x 1.8' gate. It is presently deteriorated. For this analysis it will not be considered.

(2) Repair the deteriorated concrete of the retaining wall and the spillway structure.

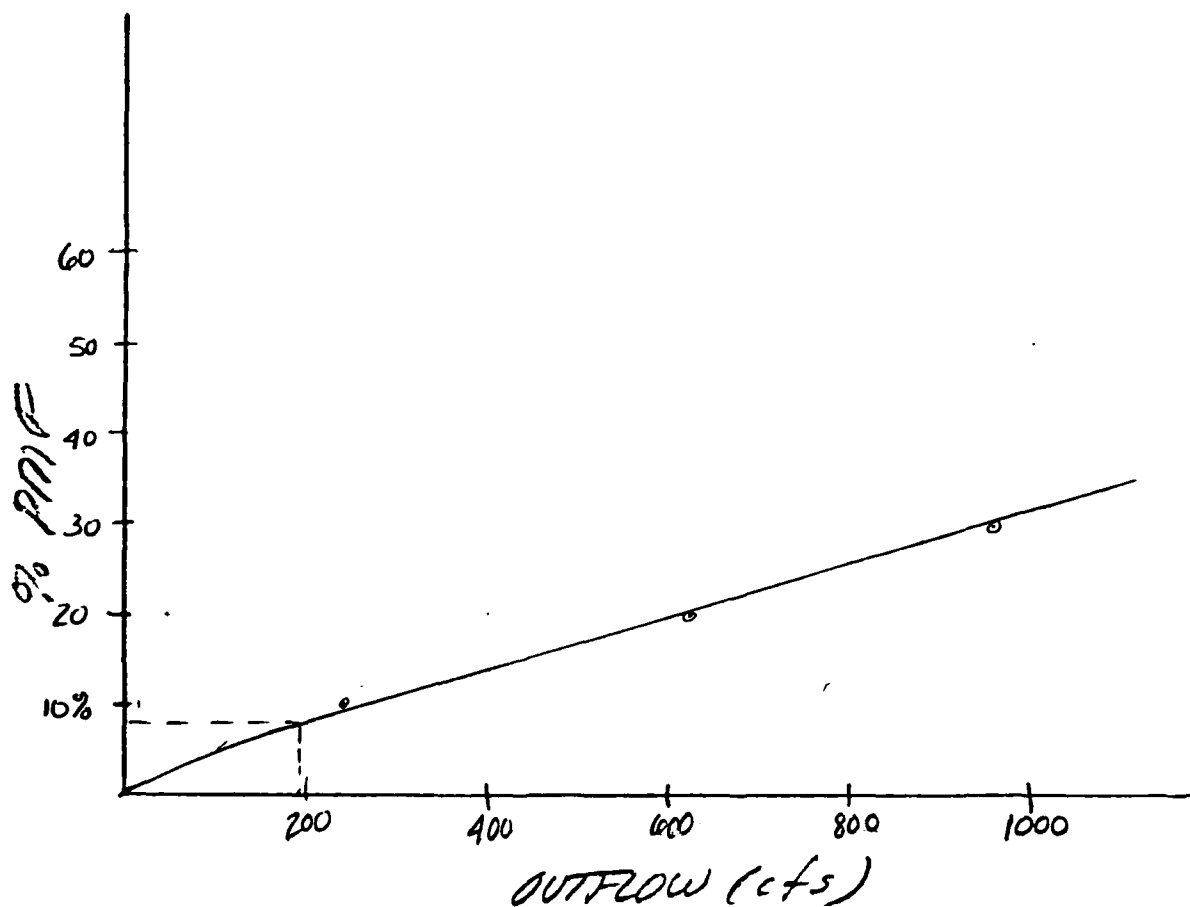
OVERTOPPING POTENTIAL

- 3) Dam overtops at elevation 100.15 with $Q = 194$ cfs \therefore dam can pass approx. 8 % of the PMF
